Detailed Seismic Assessment – Clutha District Council Main Buildings and Community Halls

Appendix A

Balclutha Information and Service Building

17 March 2017

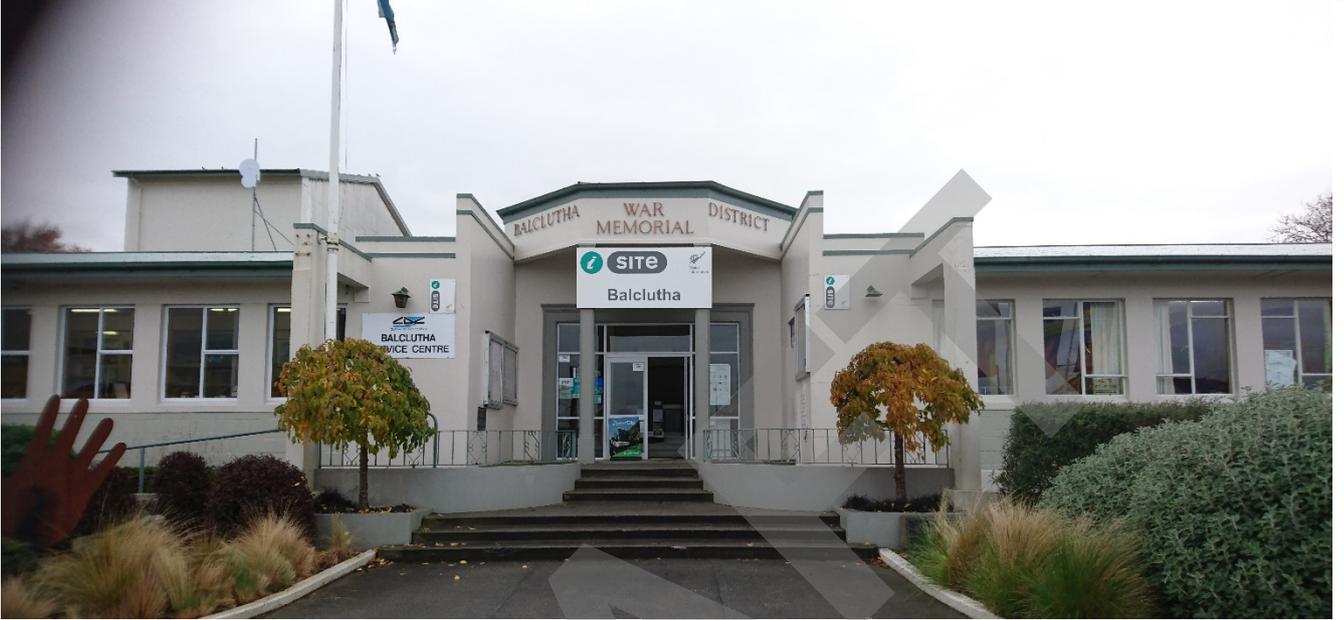
Photo 1: View of Balclutha Information and Service Centre

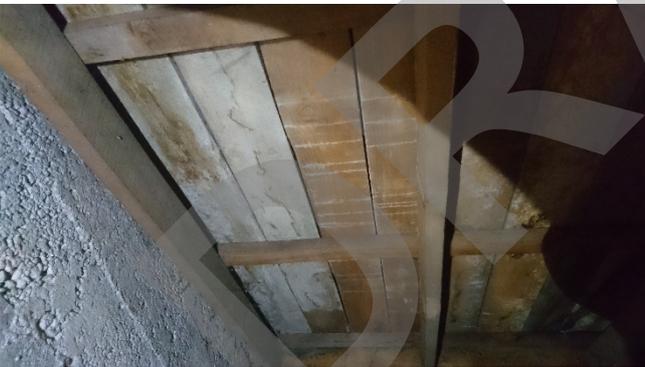
Photo 2: View of timber board roof; the concrete 'wall' to the left is part of the war memorial at the entrance

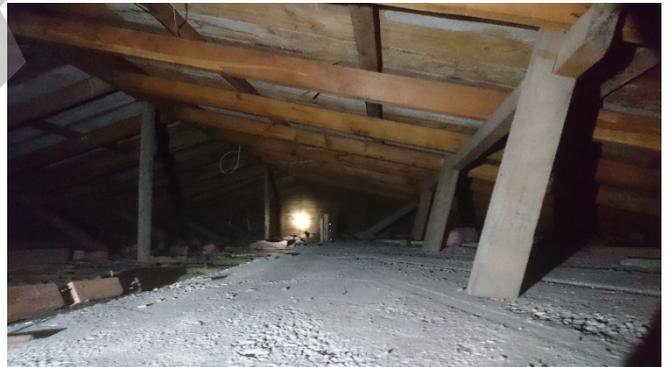
Photo 3: View of timber framed gable end, strong room concrete roof, and timber roof framing

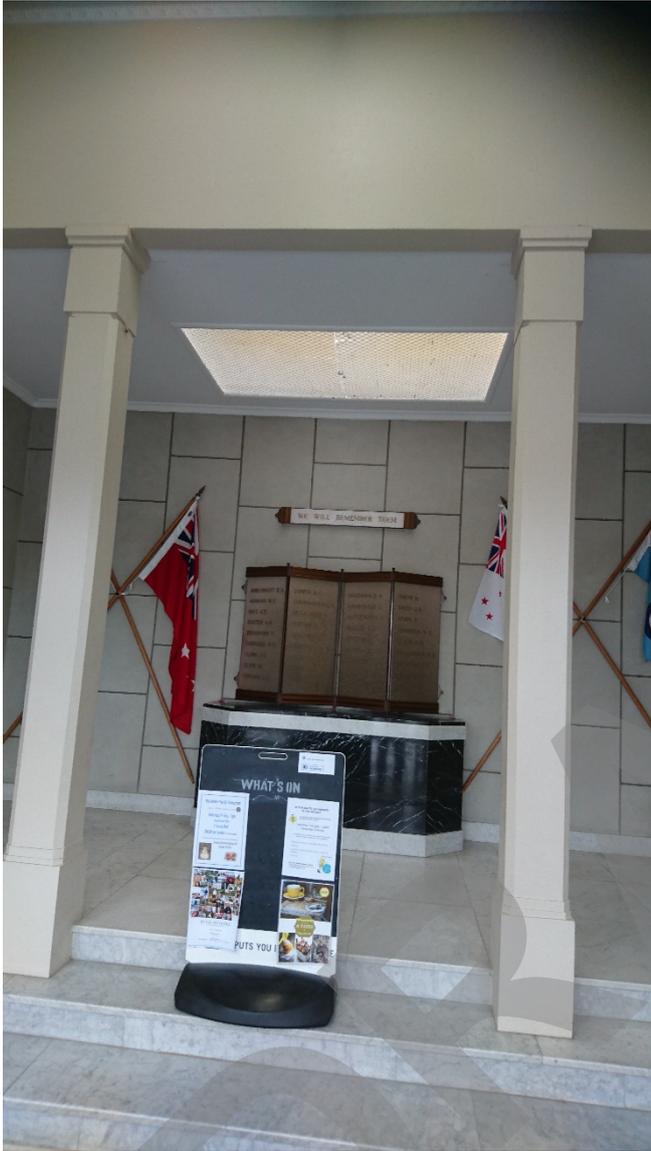
Photo 4: View inside main entrance

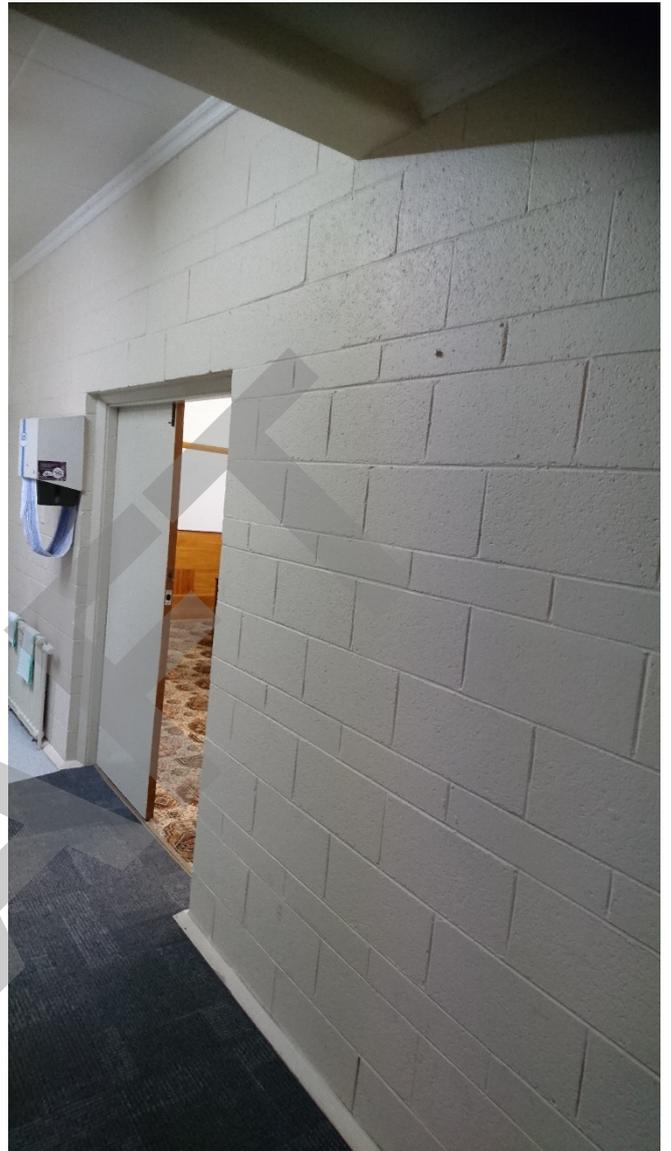
Figure 5: View of concrete block wall with reinforced concrete bond beam and concrete beam spanning overhead; the door leads to the council chambers

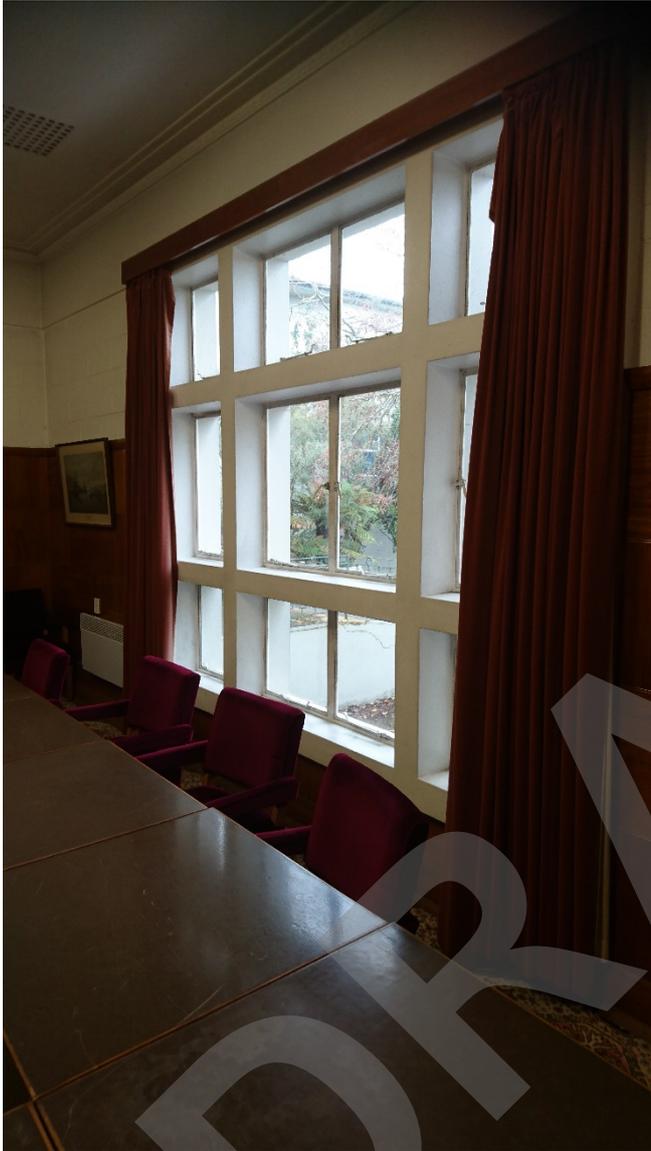
Photo 6: View of 300 thick reinforced concrete window surrounds in the council chambers

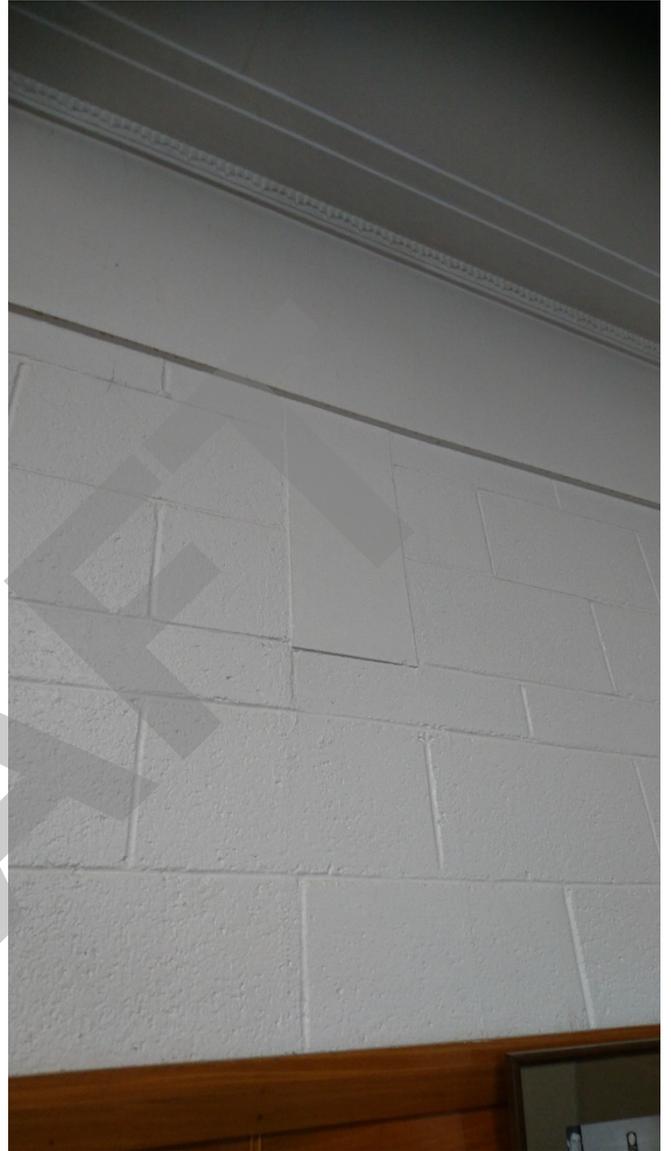
Figure 7: View of concrete block wall with reinforced concrete bond beam; note that the 'deep rectangle' in the wall is the end of a reinforced concrete beam that spans 'into the photo'

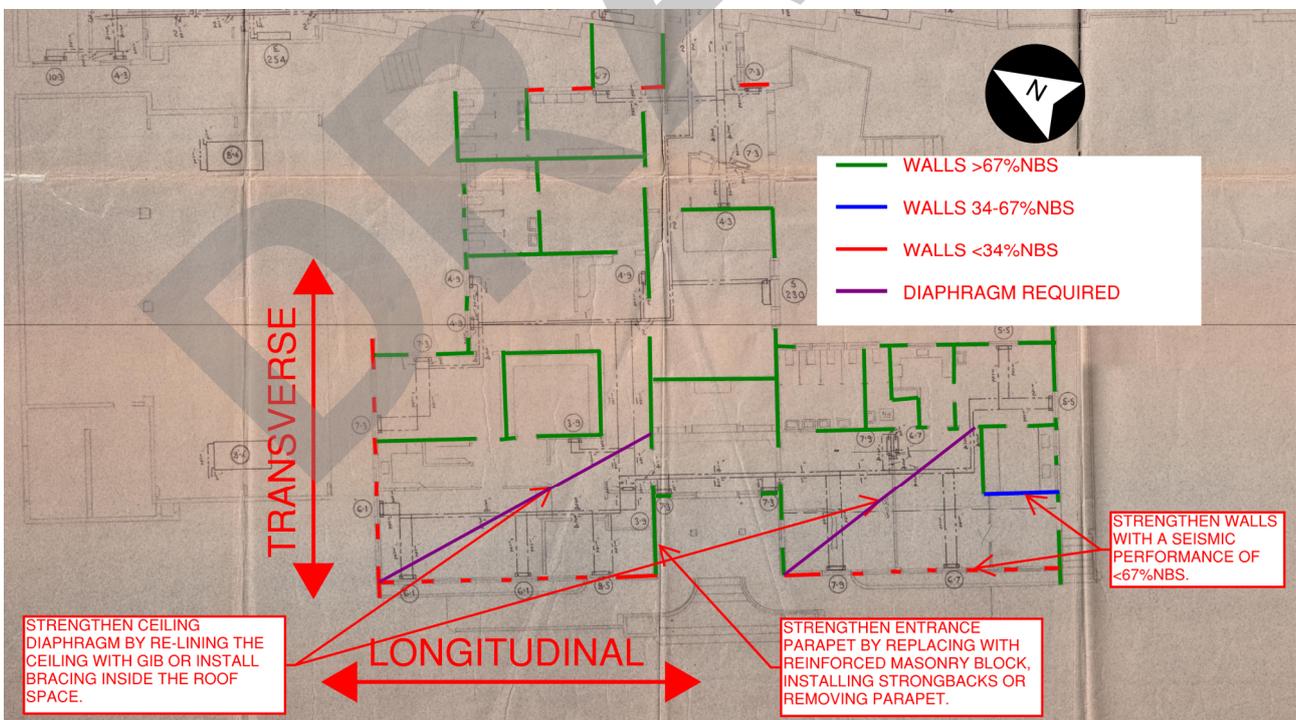
Figure 2 – Balclutha Information and Service Centre, 67%NBS Strengthening Scheme.

The seismic performance of several unreinforced masonry walls were found to be less than 34%NBS or 67%NBS. Refer to Figure 2 in Section 4 showing the location of these walls. Majority of walls in the building were found to be greater than 67%NBS.

- Strengthen the URM window frames and all walls assessed to be less than 67%NBS by any of following:
 - Replace URM window framing and URM walls with reinforced masonry block walls.
 - Place additional reinforced masonry block walls in critical brace lines.
 - Strengthen walls by adding structural steel frames.
 - Install a stiff diaphragm in the roof space to re-distribute seismic load to stronger walls.
- Strengthen out-of-plane capacity of entrance parapet by any of the following:
 - Remove URM parapet.
 - Replace URM parapet with reinforced masonry block.
 - Install strongbacks behind URM parapet.
- Strengthen the ceiling diaphragm of the building by any of the following:
 - Re-line the ceiling with GIB.
 - Install roof bracing inside the roof space.
