Toko Developments Limited
tokofarms@gmail.com
1296 Coast Road, RD 2,
Milton,
9292

Geotechnical Assessment Lot 9, DP416455 Coombe Hay Lane, Toko Mouth

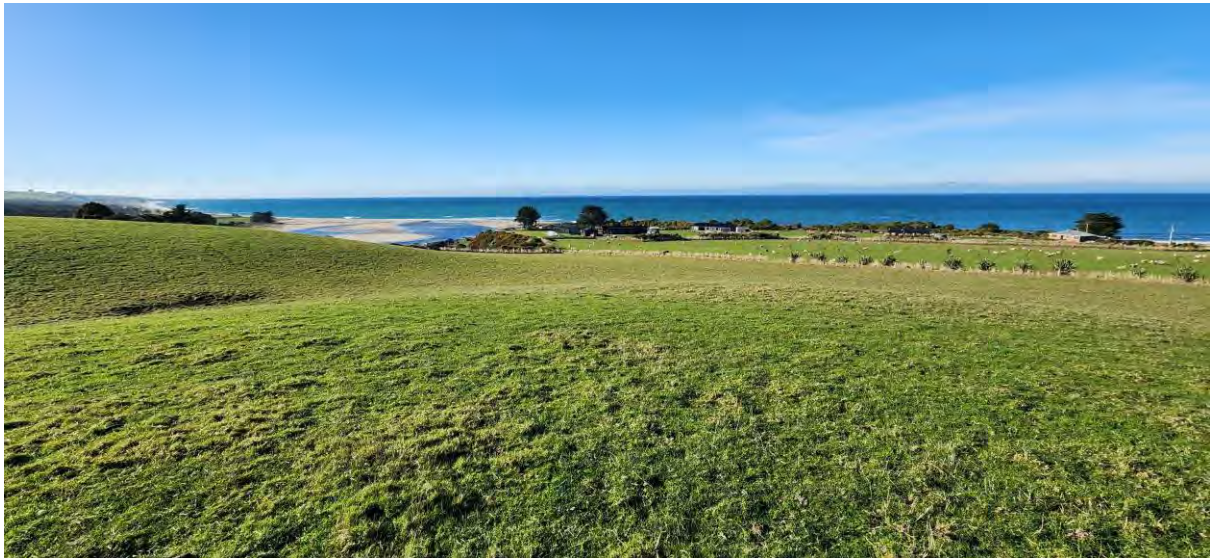
Figure 1: Proposed Subdivision location looking eastwards.

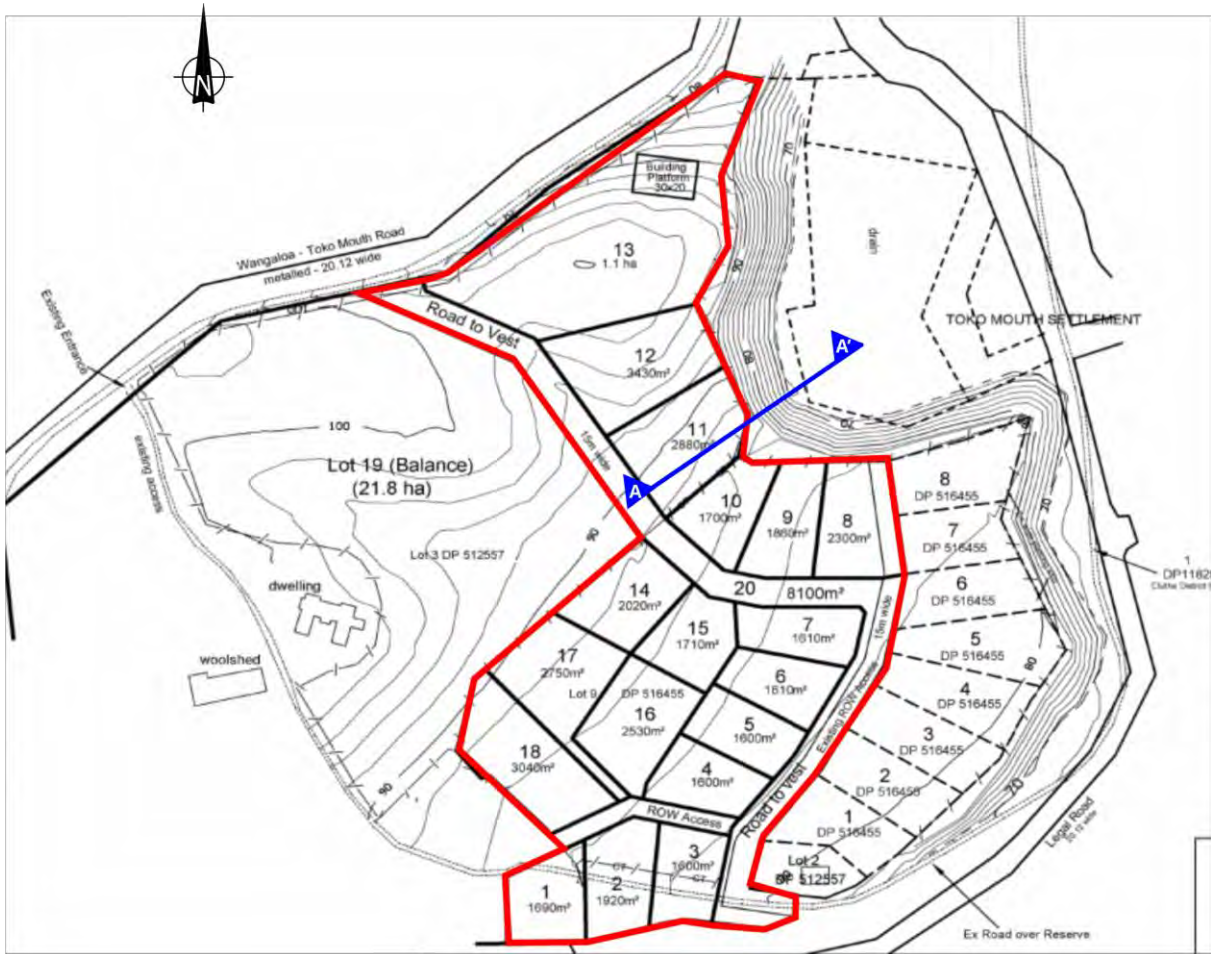
Figure 2: Proposed subdivision layout outlined in red. Snip taken from Craig Horne registered surveyor (reference Davies P67). Cross Section location is also shown.

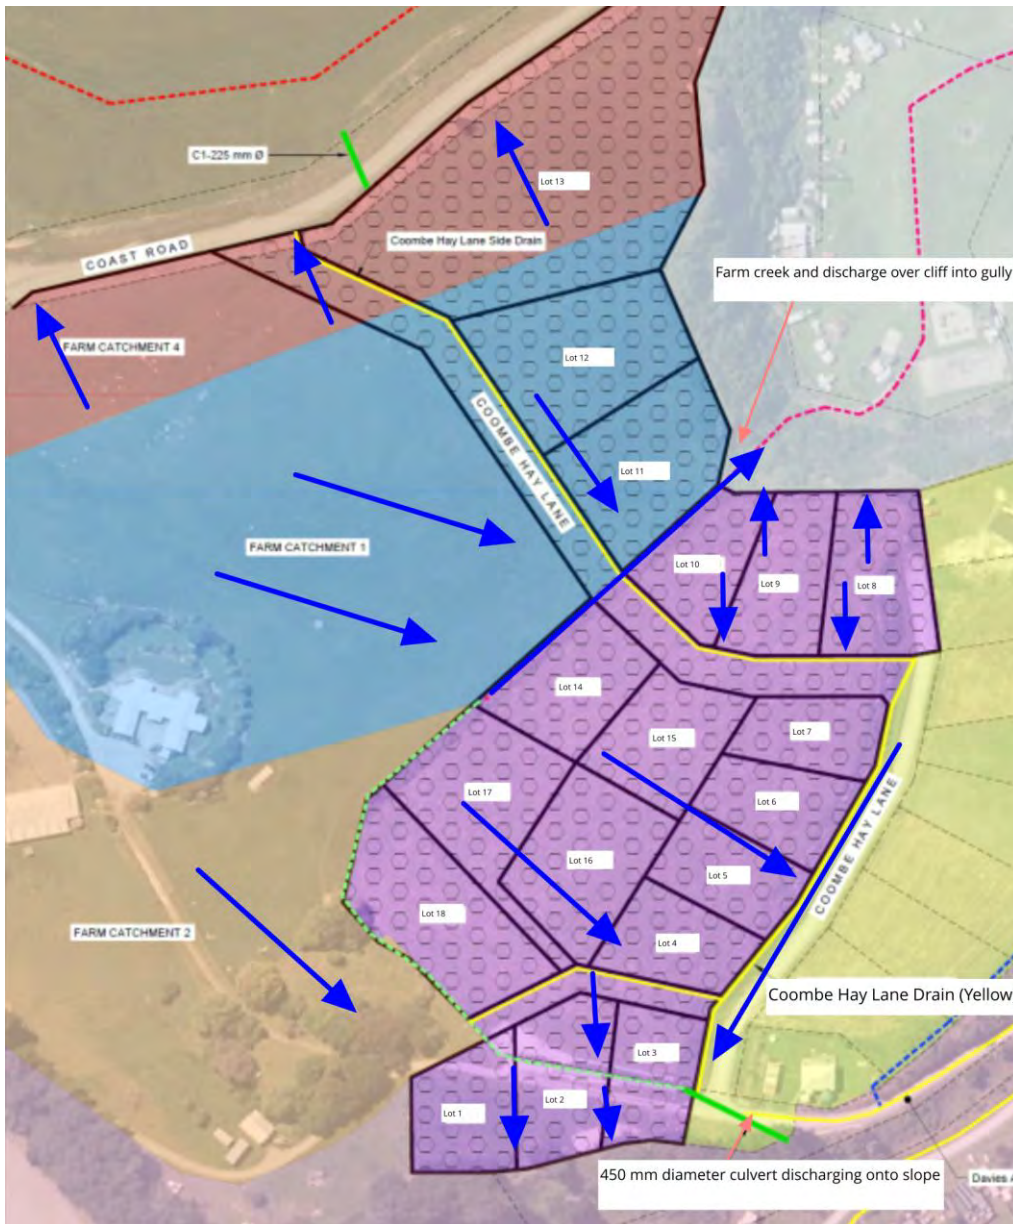
The above 3 discharge points and likely stormwater flow paths are shown in Figure 4 below. This figure also shows likely water flow paths based on a site walkover and mapping exercise undertaken.

Figure 4: Mapped catchments with likely surface water drainage paths (shown as blue arrows) based on site walkover observations.

The aerial imagery review also shows the slopes on the southern side of the terrace have exhibited minor signs of regression since 1962 however these are obscured by large trees making an assessment difficult. Due to recent tree removal and significant debris, steep slopes and vegetation the slopes in the area was unable to be accessed and visual assessment of the slopes was difficult. It was also not possible to identify the outfall of the 450 mm culvert located at the southern end of the site which drains under Davies Accessway (see figure 4). As part of the development, we recommend identifying its

location and confirming it is still suitable for stormwater discharge and that there are no obvious areas of additional instability.

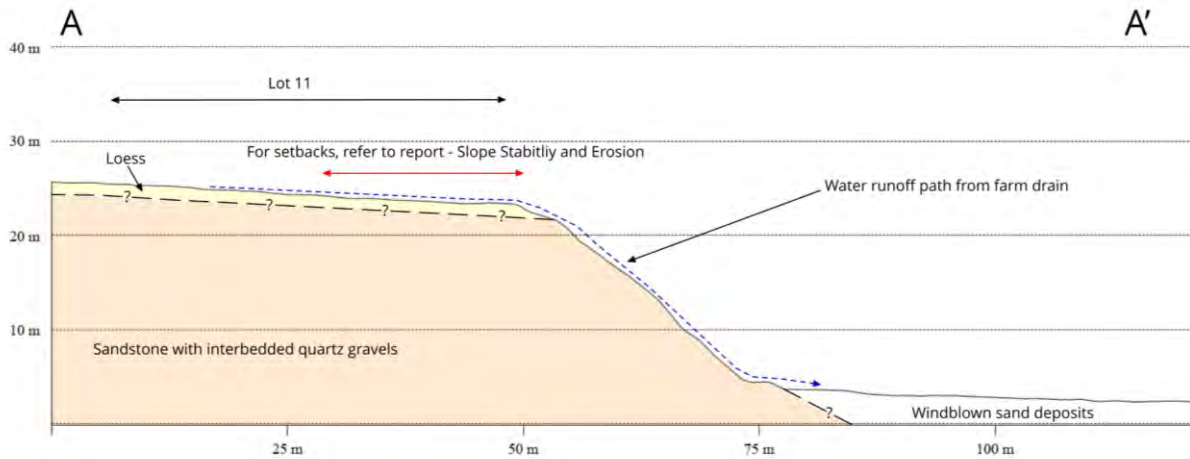
As discussed above, the proposed subdivision is located on an elevated marine terrace, with an escarpment surrounding it up to 10-30 m in height. The underlying geology of the

terrace comprises fine grained sandstone with quartz gravel layers. There is a surficial layer (approximately 1-2 m) of loess overlying the sandstone. The steep slopes have overall angles of between 30-50 degrees with some steeper areas.

Figure 5: Schematic Section of the marine terrace escarpment.

Based on this assessment we consider the following setbacks are appropriate for residential dwelling construction with a design life of 50 years based on a 2(horizontal):1(vertical) line from the base of the cliffs:

- A set back of 20 m from the crest of the slopes on Lot 13;
- A setback of 15 m from the crest of the slope for the remainder of the subdivision;
- Setbacks on lots 10 and 11 should be taken from the crest of the V shaped water runoff channel.
