Balclutha Information and Services Centre

Seismic Assessment – Initial Evaluation Procedure (IEP)

November 2014

Prepared by: Opus International Consultants Limited

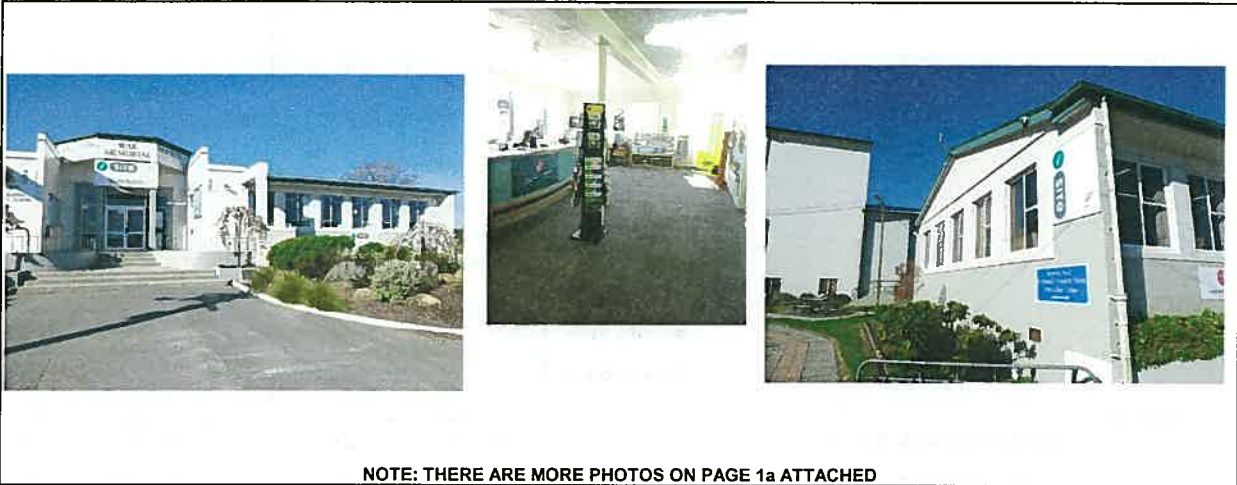
1.1 Photos (attach sufficient to describe building)

Structure = Single-storey unreinforced concrete block building. Lightweight corrugated iron roof cladding, timber framed roof and a concrete perimeter ring foundation with piles. Internal walls are concrete block with concrete strip foundations directly underneath. One half of the building is the Balclutha Plunket rooms. The council chambers and lobby of the Town Hall are connected and of the same construction.
 Height = 5.5m approximately to the apex of the roof.
 building date = Designed in 1954
 Soil class = D (Soft Soil)
