Detailed Seismic Assessment – Clutha District Council Main Buildings and Community Halls

Appendix A

Balclutha Information and Service Building

17 March 2017

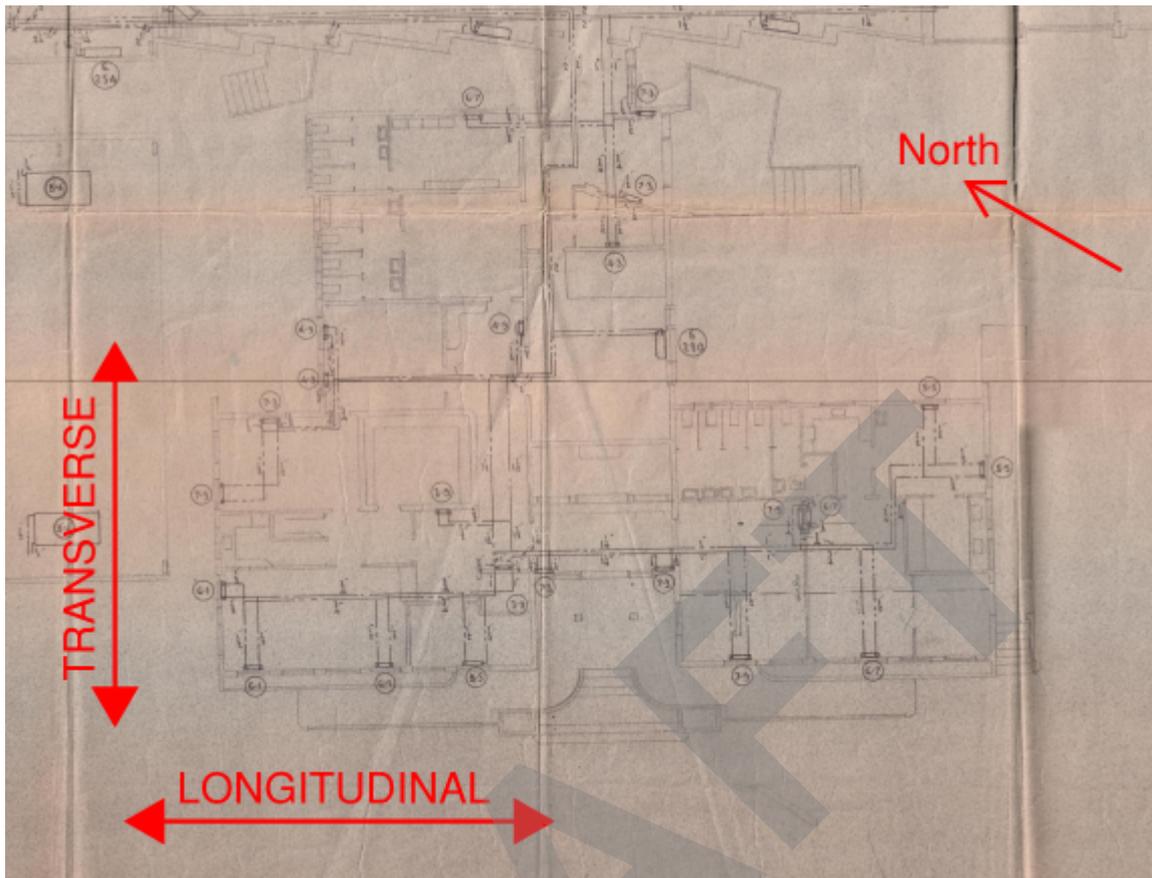
Figure 1 – Balclutha Information and Service Centre, Floor Plan

The lateral load resisting systems for Balclutha Information and Service building are identified to be:

- Seismic loads in the Balclutha Information and Service Centre are predominantly resisted by unreinforced masonry walls in both the North-South and East-West directions. Reinforced concrete bond beams are feature above all masonry walls.
- Seismic loads from the roof are transfer to the masonry walls through the timber roof structure as a flexible diaphragm.
